Remediation Weekly Activity Summary Report
Ameren LaSalle Former MGP - Soil Removal Action

Period: April 13 through 19, 2015 (Week 83)
Completed By: Mark Kroenig

PSC Project Number 624-1202-0012

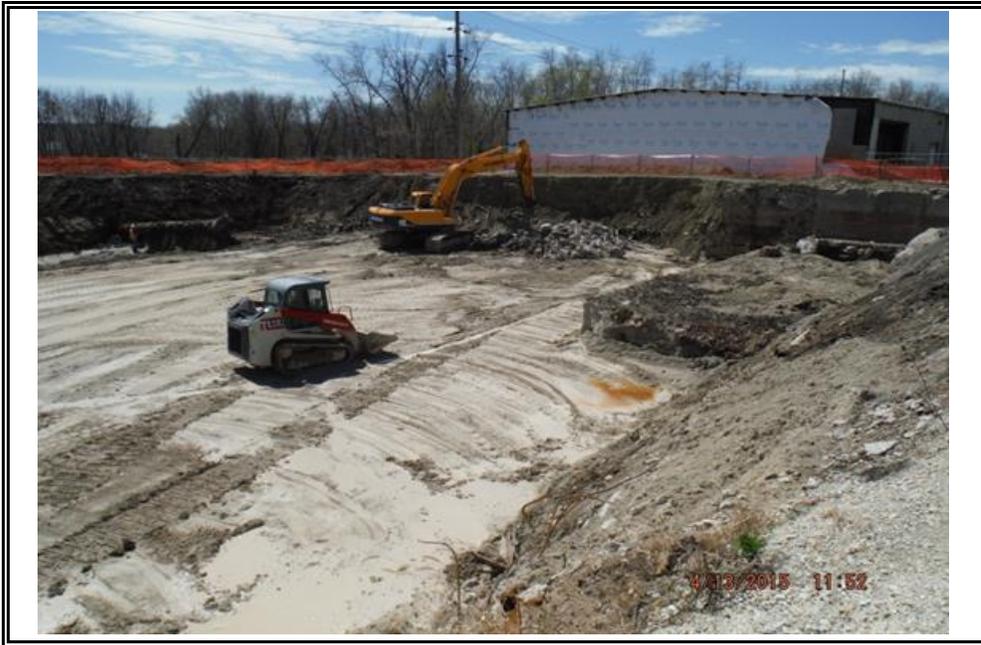
Looking southwest in Phase 8, equipment working on drying Phase 9 excavation bottom and preparing to load out more debris.

Loaded out demo debris, logs, and impacted soil with one truck running. Crew loaded the truck and dried the bottom of the excavation. 40" intake pipe was left intact in place to prevent the chance of flooding the excavation. Confirmation samples were collected from beneath the 40" pipe, which were picked up by STAT Lab.

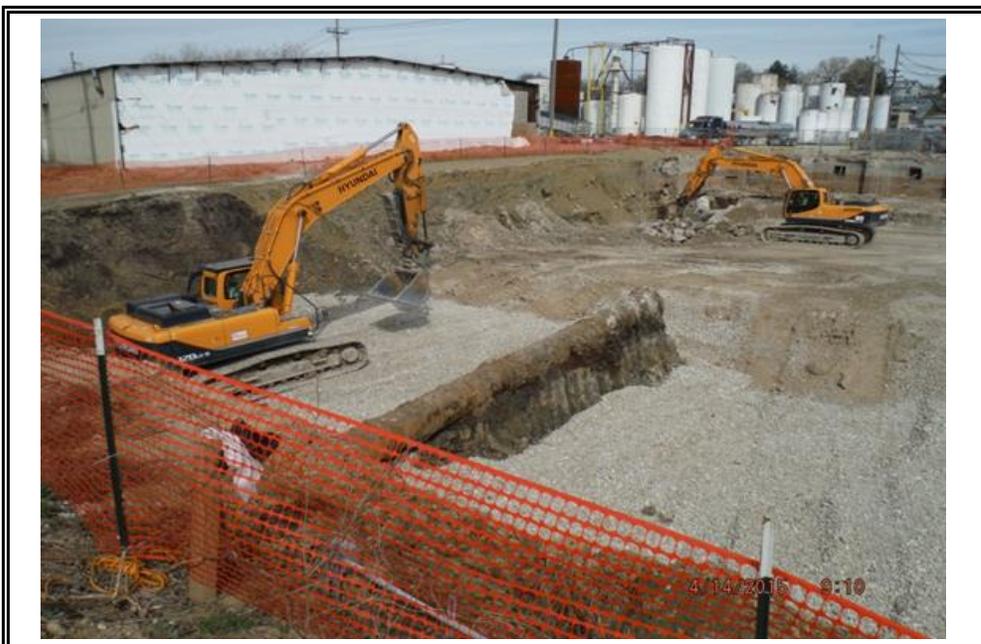
Looking northwest at Phase 9, excavators spreading stone backfill and loading demo debris.

Loaded out approximately 5 loads of demo debris with one Kirschhoffer truck. 4 Pohar backfill trucks delivered 1" x 3" stone and lime screenings to begin backfilling Phase #9.

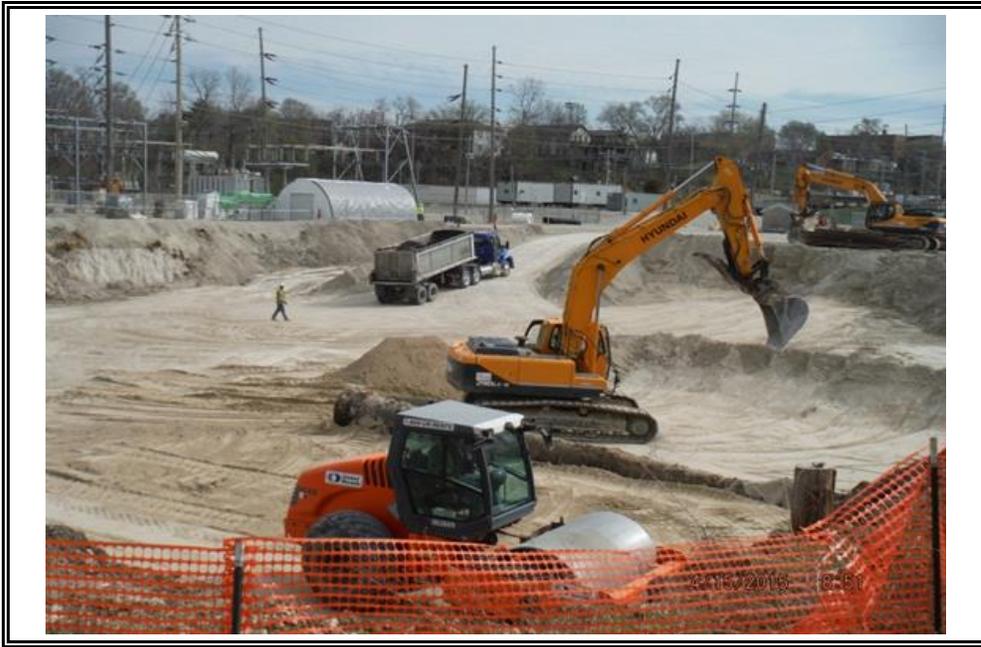
Looking northeast at Phase 9, backfill progress on 4/15/15.

Continued backfilling with lime screenings from Utica Quarry. 4 Pohar trucks hauled in backfill. A newspaper reporter and photographer visited the site to take photos. QLF aerated the storm water basin.

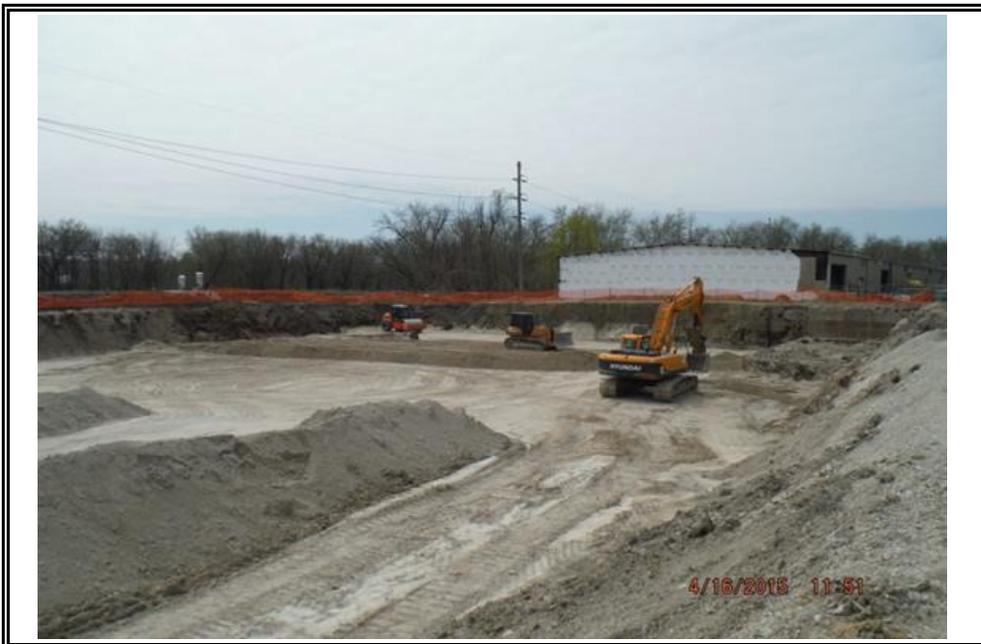
Looking west, equipment spreading lime screenings on Lift #9 at 14 feet bgs to backfill Phases 7, 8, and 9.

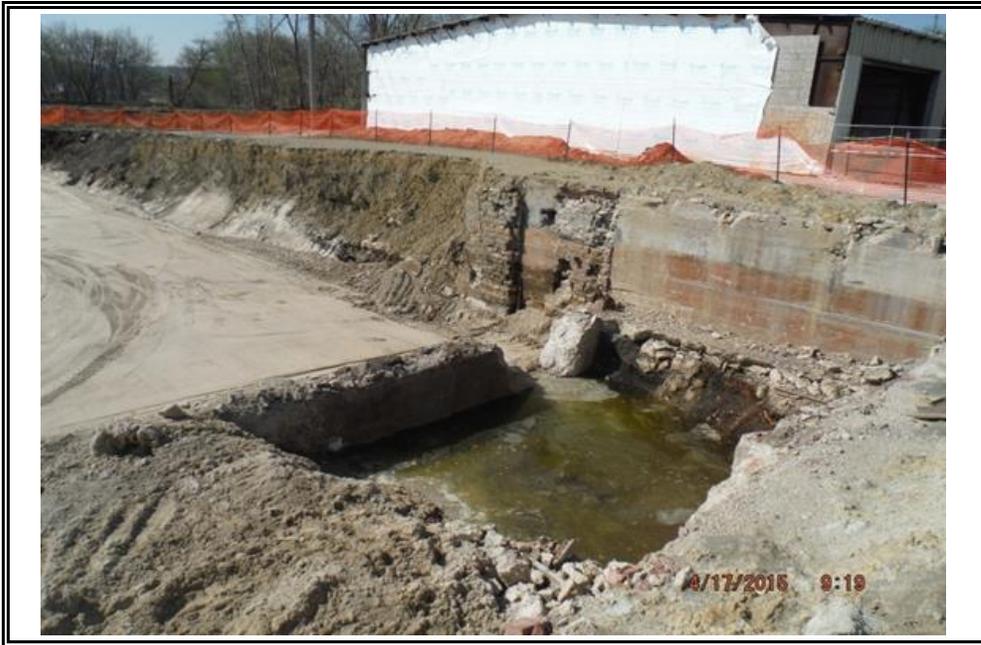
Water accumulating in the NE corner of the old vault area. Pumping into a frac tank.

Continued to backfill Phase 9 with 5 trucks from Pohar. Pumped accumulated water from the old vault area into a frac tank. Midwest Testing was on site to take compaction tests on the east half of Lift #9. All 6 tests passed. The EDG was calibrated to an average of within 2% the nuclear density gauge results. PSC will use the EDG for compaction testing next week. QLF aerated the storm water basin.

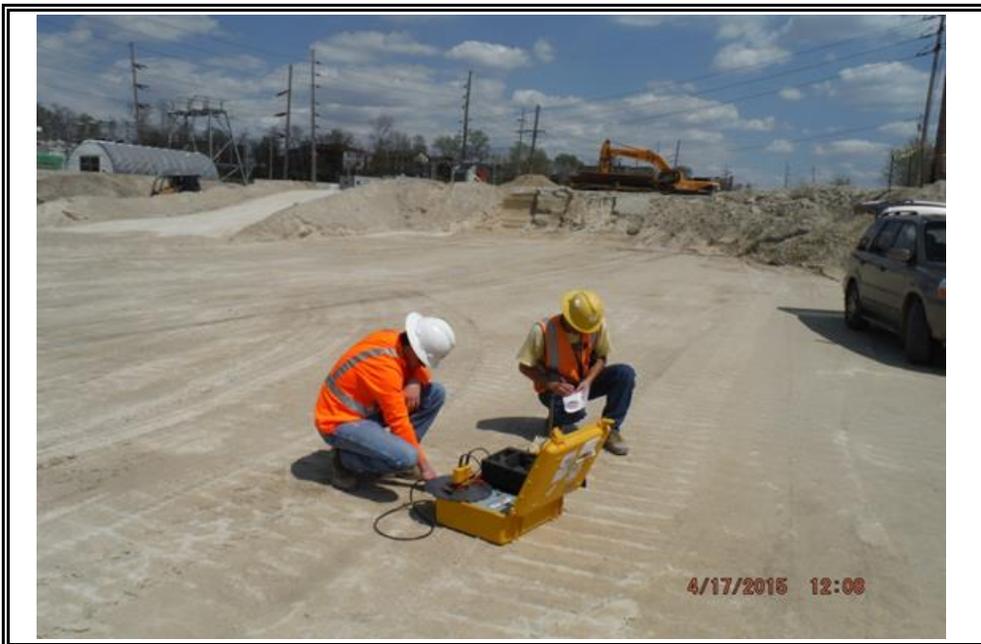
Midwest Testing taking a compaction test on Lift #9 while PSC takes compaction test with EDG.

Backfill continued today with 5 trucks from Pohar. Midwest Testing was on site to take compaction tests on the west half of Lift #9, which was approximately 50% completed. All 6 tests passed 95% compaction. PSC calibrated the EDG to match Midwest's readings. QLF aerated the storm water basin. The generator QLF used to power the pump was causing the results from the closest air monitoring stations to spike. PID readings read 0 prior to the generator being started and up to 7 ppm from 100 feet away while it was running.

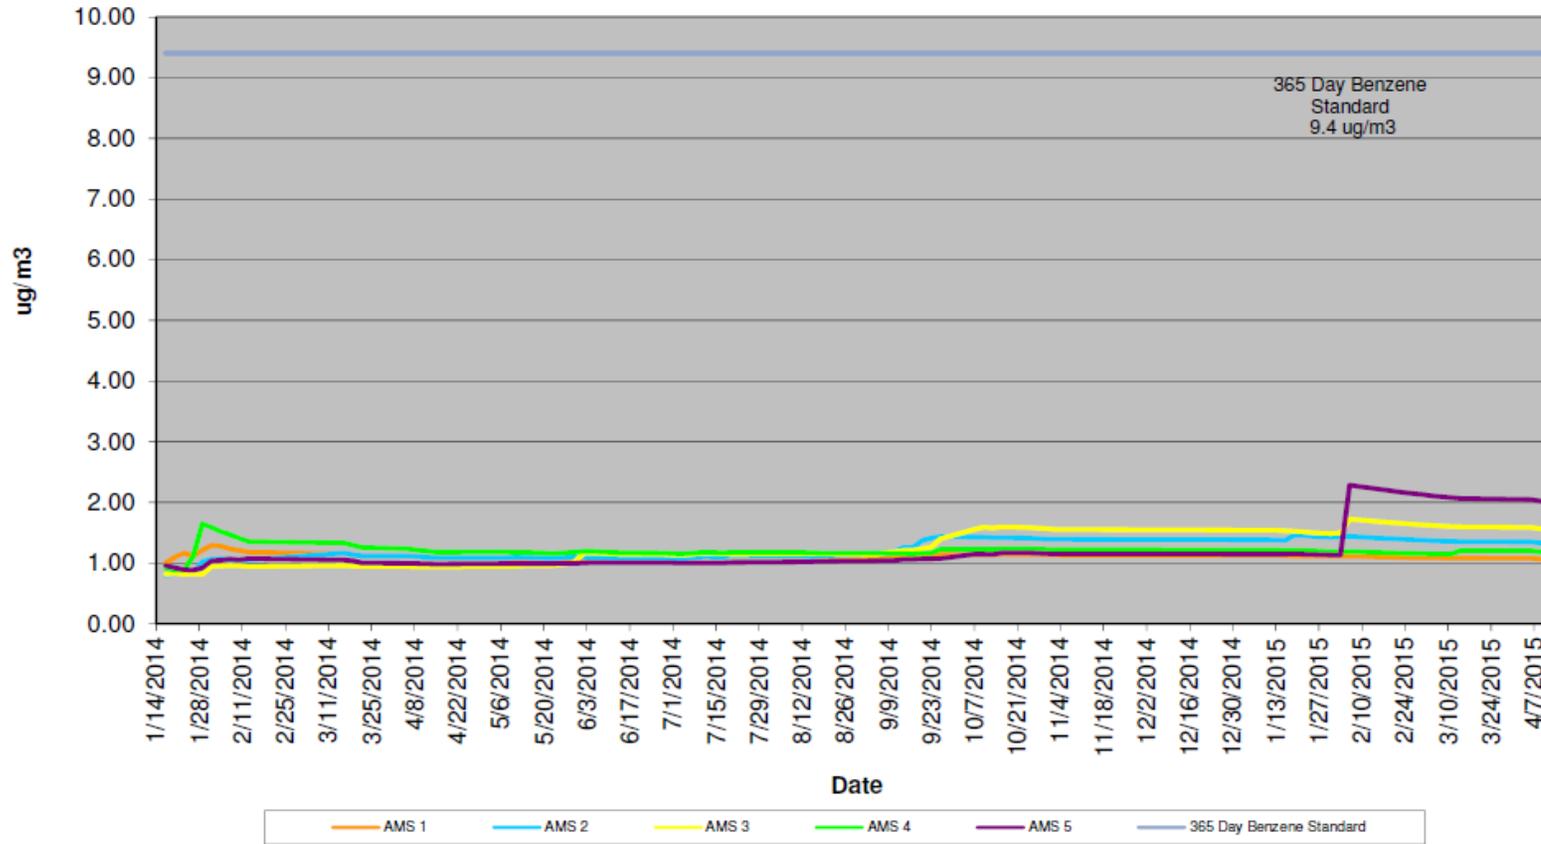
Preliminary Benzene Running Averages
LaSalle MGP Site
1/14/2014 - 4/12/2015

- Time-integrated sampling results for sampling events thru include sampling events thru March 20th were reported via email on April 8th. Analytical results to date for benzene, PM₁₀ and PAHs indicate that the running average air concentration at each air monitoring station is less than the risk-based standards calculated for the project. CEC will continue to update results as analytical data becomes available.
