**Remediation Weekly Activity Summary Report
Ameren LaSalle Former MGP - Soil Removal Action**

Period: March 10 - March 16, 2014 (Week 26)
Completed By: Jeff Adams

PSC Project Number 624-1202-0012

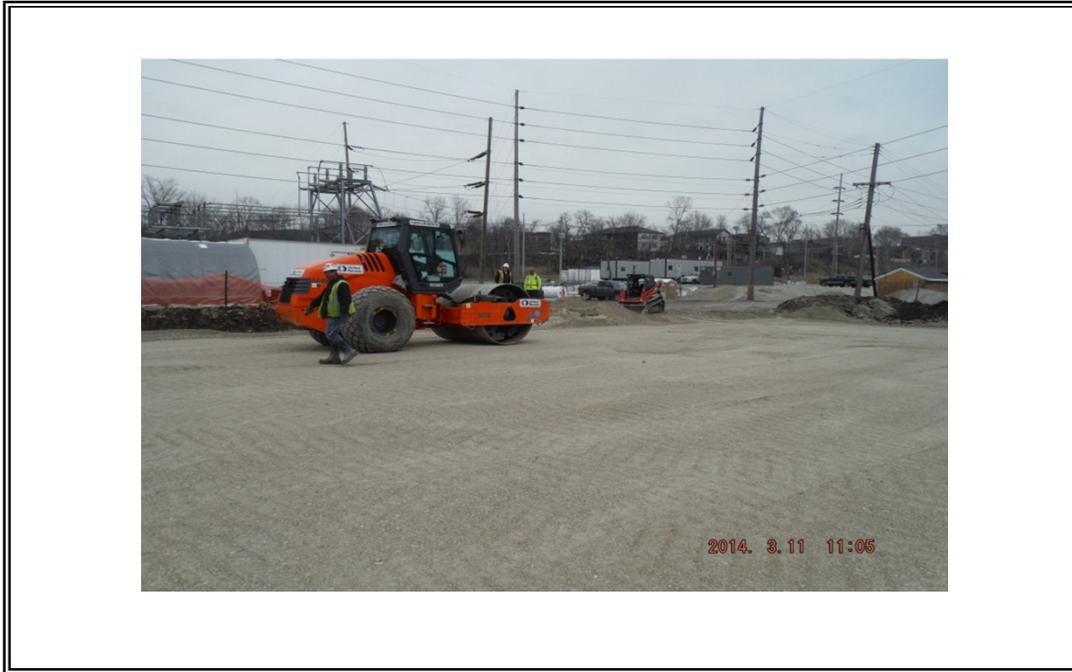
Photograph of compactor working on lift # 23, all 3 compaction tests passed.

Completed backfilling and compaction of excavation with 1-inch minus rock, performed in 1-foot lifts (Lifts 23). No accumulated water in the Site excavation. Compaction tests performed by Midwest Testing Services, Inc. (Midwest). In addition, started prepping for the 2nd excavation. Rock backfill is being sourced from Vulcan's Lisbon Quarry.

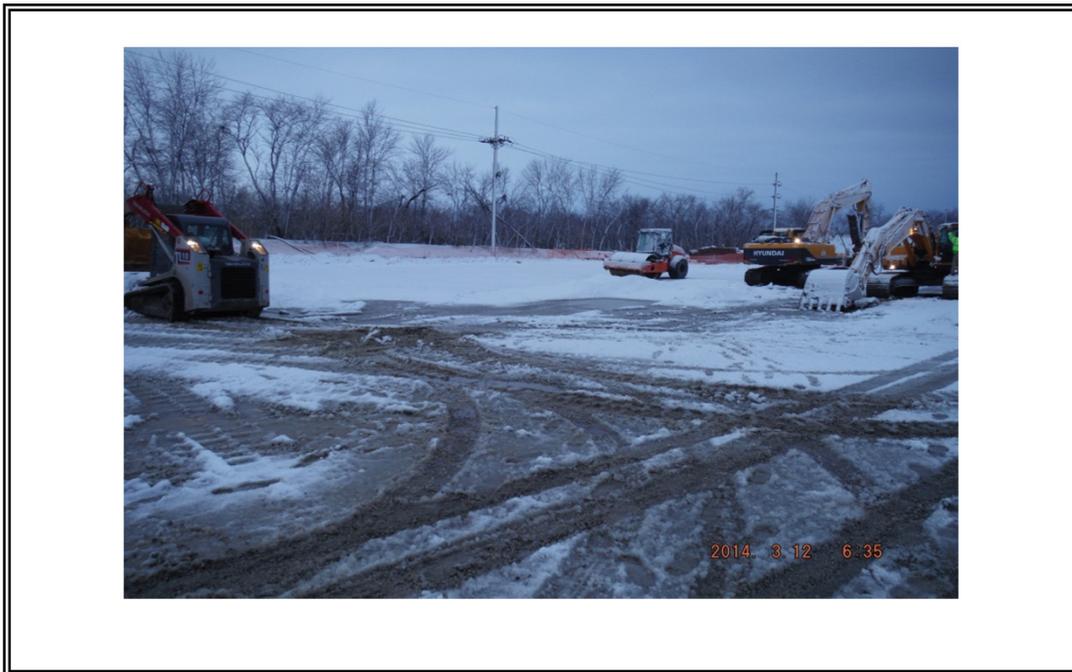
Photograph looking southwest at site after 1" of rain and 2.5" snow overnight.

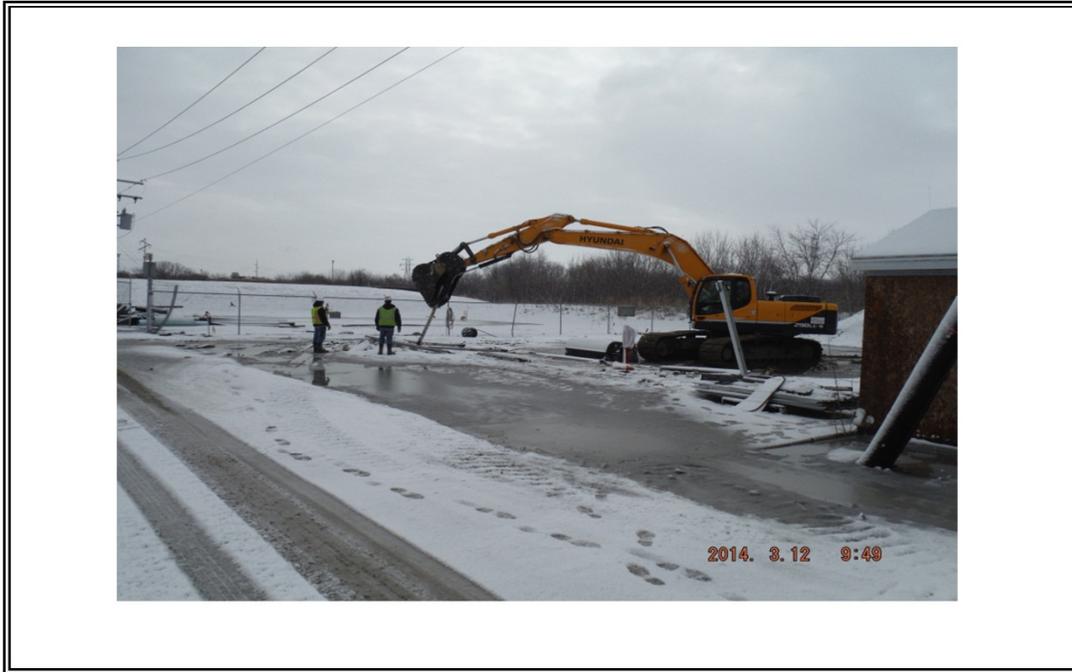
Photograph of crew pulling roof and post at the pistol range.

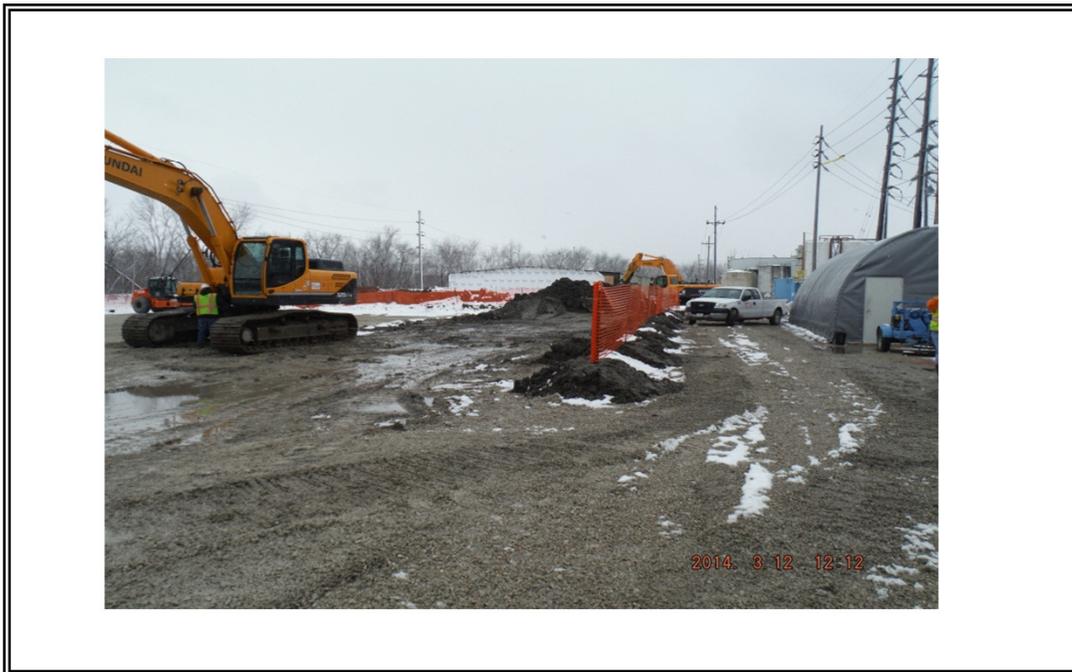
Photograph looking west at placed berm and fence put up for Phase 2 excavation.

Prepped for Phase II Excavation by placing berms, putting up silt fence, and improving stone access roads. Overnight rain, turning into snow.

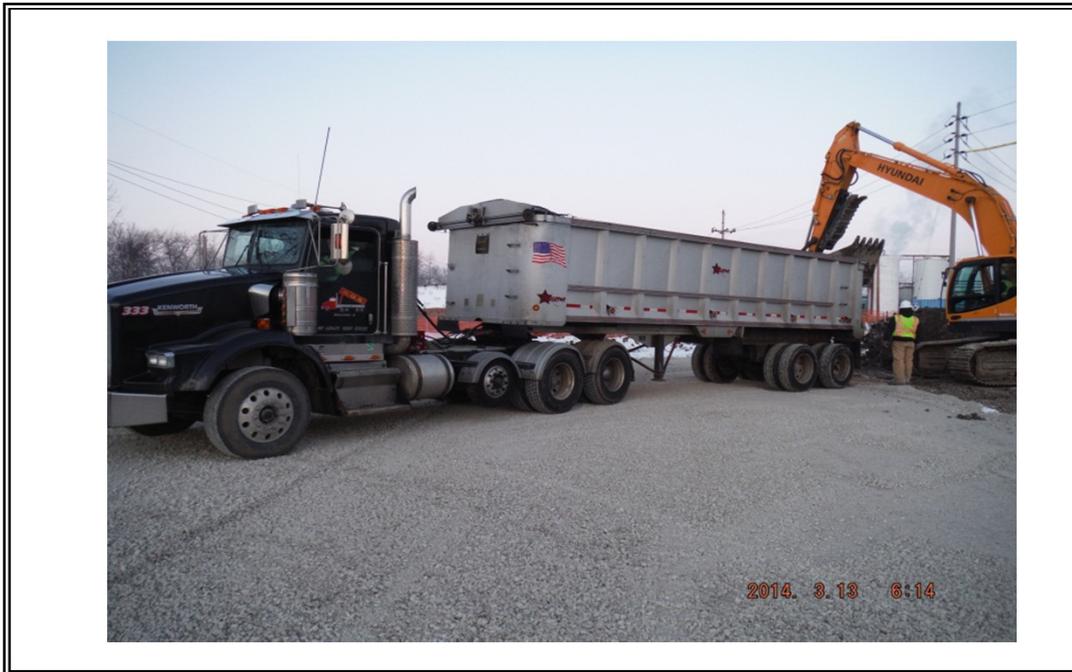
Photograph of the loading of the 1st truck load from the Phase 2 excavation.

Resume excavation of impacted material from Phase II excavation. Approximately 746 tons of material were removed and transported to Republic's Ottawa, Illinois landfill. The Illinois River crested 2.1 feet over flood stage.

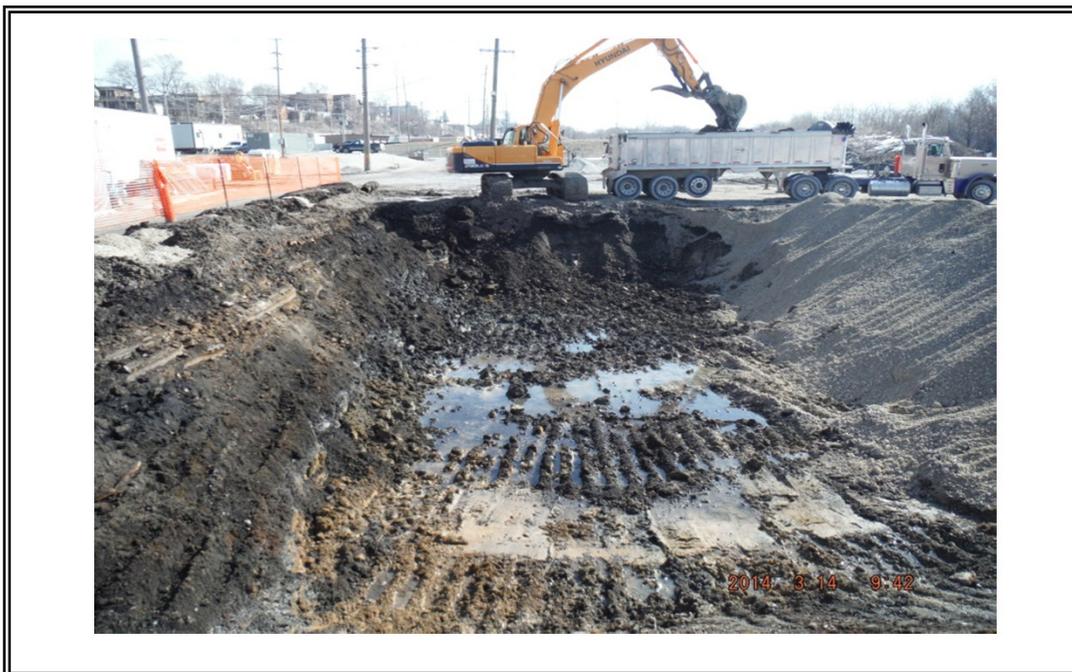
Photograph looking east at the 290 excavator loading impacted material.
